# Long-term Follow-up Survey on Sulfuric Acid Resistant Mortar

# Background of the Follow-up Survey

# Follow-up Survey Overview

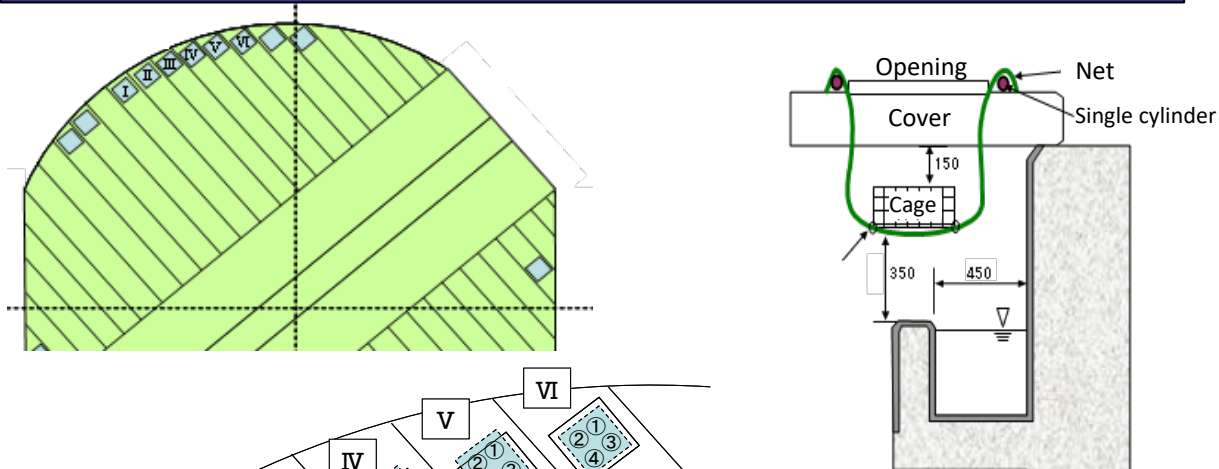
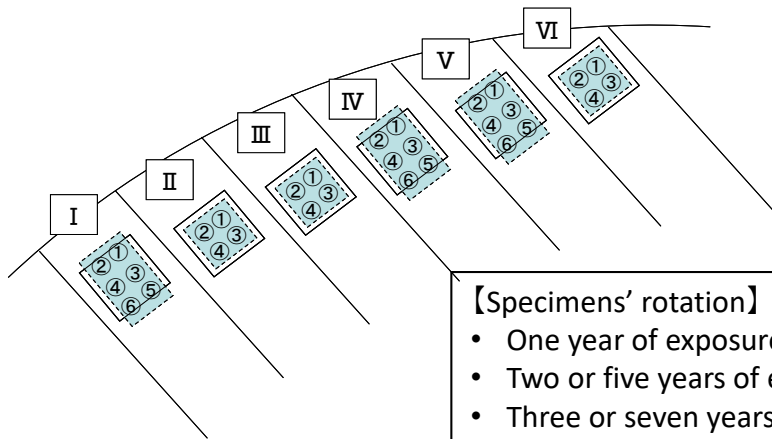
## Plane and cross-sectional views of the primary settling tank

- Installed in the gas phase of the six apertures (I to VI) of the cover of the specimen
- Installation locations were rotated every year.

- One year of exposure :Installed in II and IV
- Two or five years of exposure: Replace II and IV
- Three or seven years of exposure: Replace III and V
- Ten years of exposure: Replace I and VI
