Visiting Fiji

International Affairs Department

From May 24, 2024, I visited relevant organizations in Fiji to discuss the formation of a sewerage project in the Republic of Fiji. I visited the Fiji Ministry of Public Works, the Water and Sewerage Corporation (WAF), the Japanese Embassy in Fiji, the JICA Fiji Office, and other organizations to discuss the prospects for sewerage projects in Fiji.

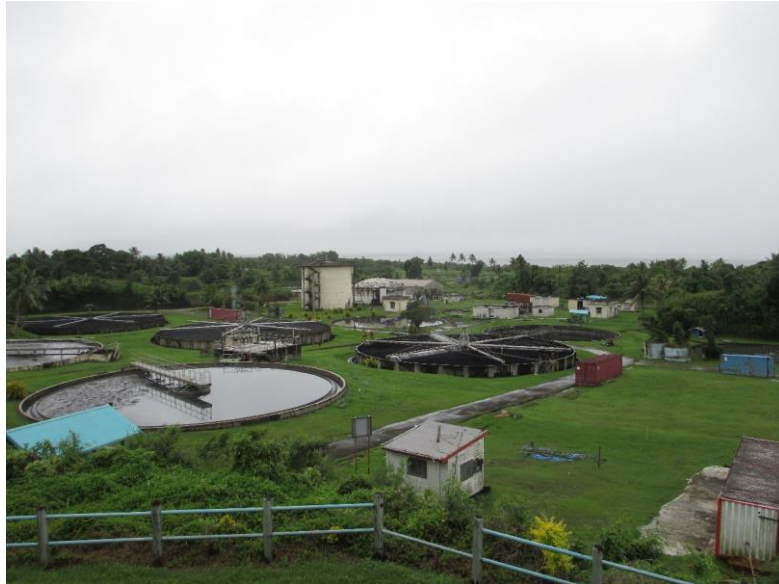
Panoramic view of the Kinoya treatment plant

From the front, the primary sedimentation tank, the spray filter bed, and the final sedimentation tank are arranged in that order. The digestion tank is also visible in the distance.

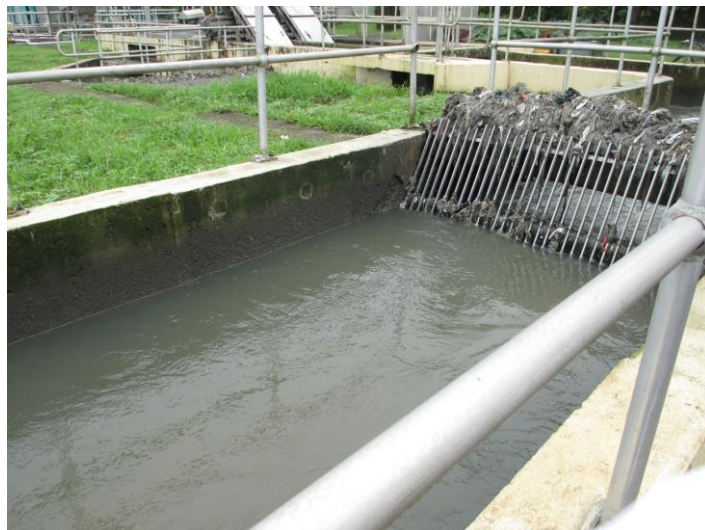
The state of the inflowing water

It was even grayer than in the photo, and there was not much of a smell.
